Application Fact Sheet - Screw Conveyor Cost Savings

Animal Feed Screw Conveyor

Screw Conveyor Shaft Wear Solution

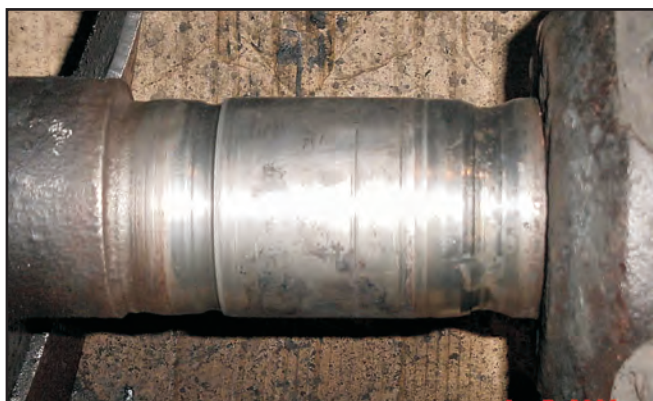
A customer was having problems with rubbing seals which were creating excessive wear and damage to screw conveyor shafts on an animal feed conveyor. This created high maintenance costs and limited operational use of the conveyor.

Above: Typical annual shaft damage prior to conversion.

To rectify the problem, Cooper recommended shaft wear collars to be fitted to either side of the 01E 90mm EX (Expansion) bearing installed in a special strap hanger application on the shaft of the screw conveyor.

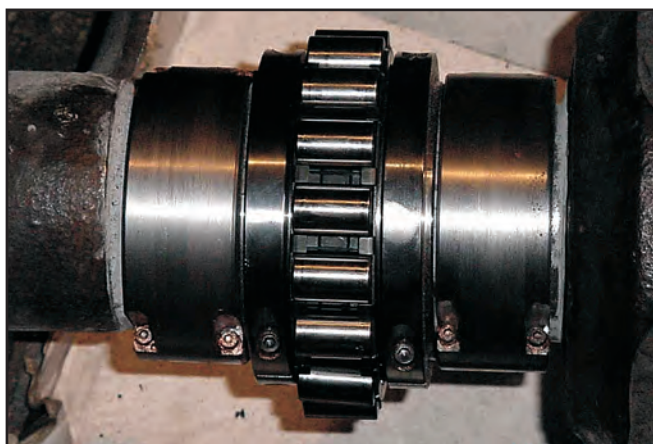
Below: Wear collars shown in position before fitting of housing.

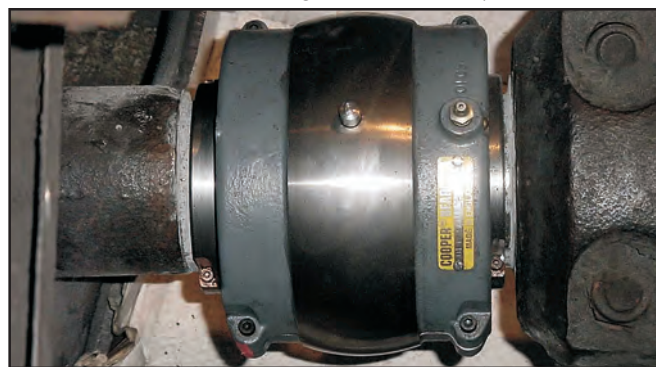
Below: Installation of cartridge in screw conveyor.
