Application Fact Sheet - Screw Conveyor Cost Savings

Animal Feed Screw Conveyor

Screw Conveyor Shaft Wear Solution

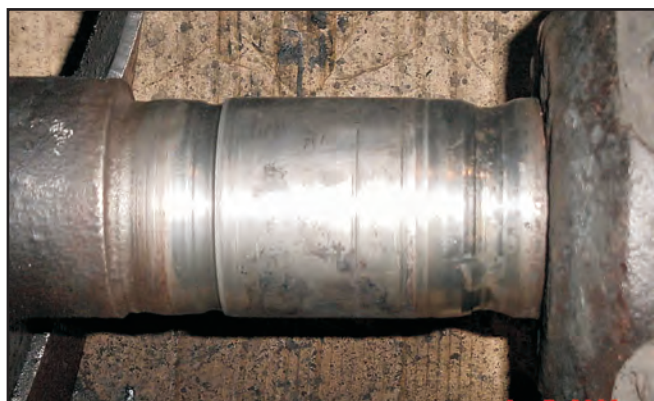
Above: Typical annual shaft damage prior to conversion.

A customer was having problems with rubbing seals which were creating excessive wear and damage to screw conveyor shafts on an animal feed conveyor. This created high maintenance costs and limited operational use of the conveyor.

To cope with these problems, the customer had a regular bearing change-out and shaft rebuild during the annual maintenance period which incurred regular shaft rebuild costs in the region of £350. An additional bearing changeout was also required during production every year.

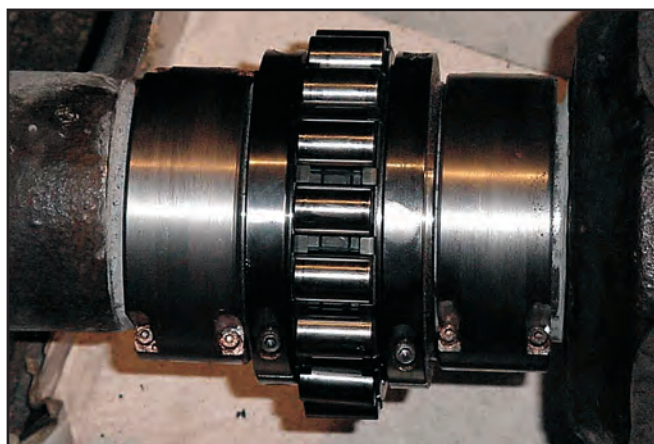
Below: Wear collars shown in position before fitting of housing.

To rectify the problem, Cooper recommended shaft wear collars to be fitted to either side of the 01E 90mm EX (Expansion) bearing installed in a special strap hanger application on the shaft of the screw conveyor.
